# Change is Good - A Story of Brine, Biology, Backwashing, and Bad Steel in Batavia

CITY OF  
BATAVIA

# **WATER TREATMENT PLANTS MODIFICATIONS PROJECT SCOPE**

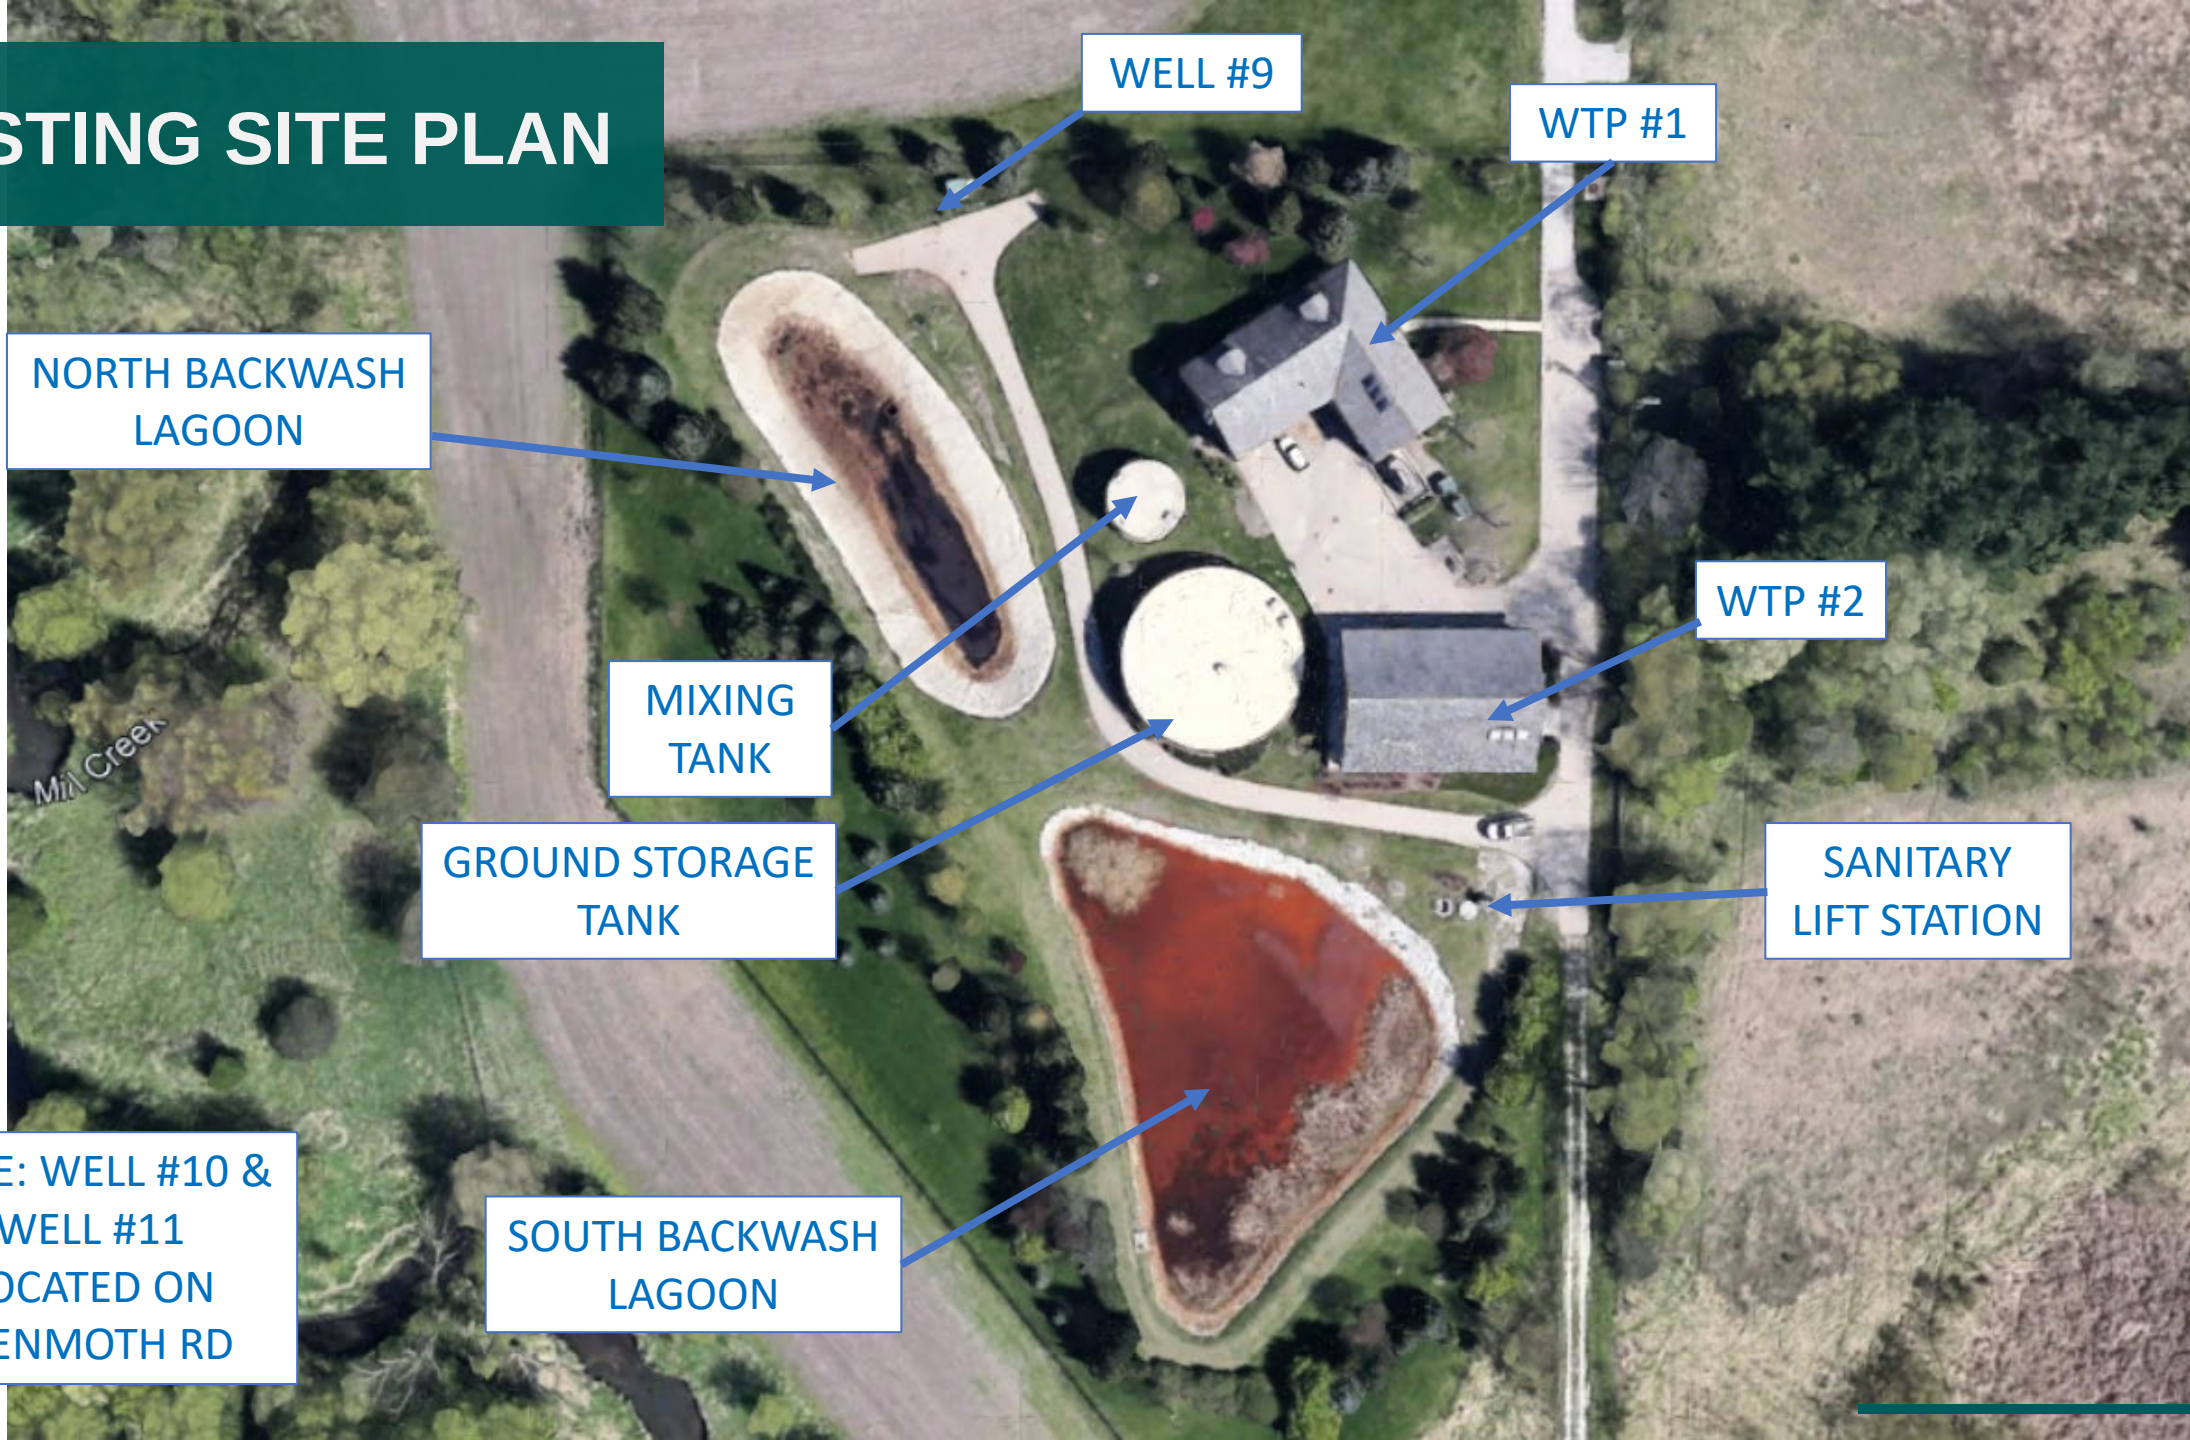
# EXISTING SITE PLAN

NORTH BACKWASH  
LAGOON

WELL #9

WTP #1

WTP #2

SOUTH BACKWASH  
LAGOON

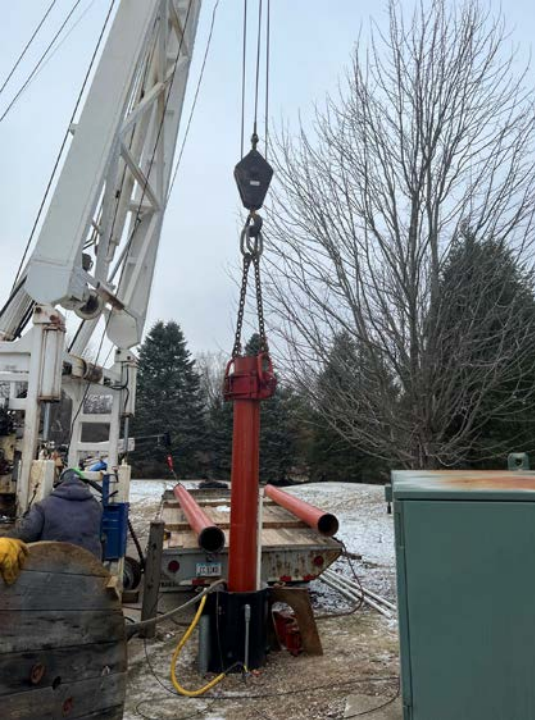
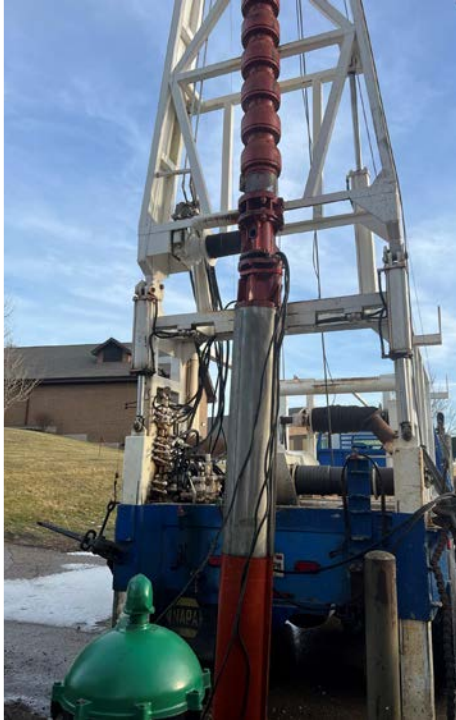
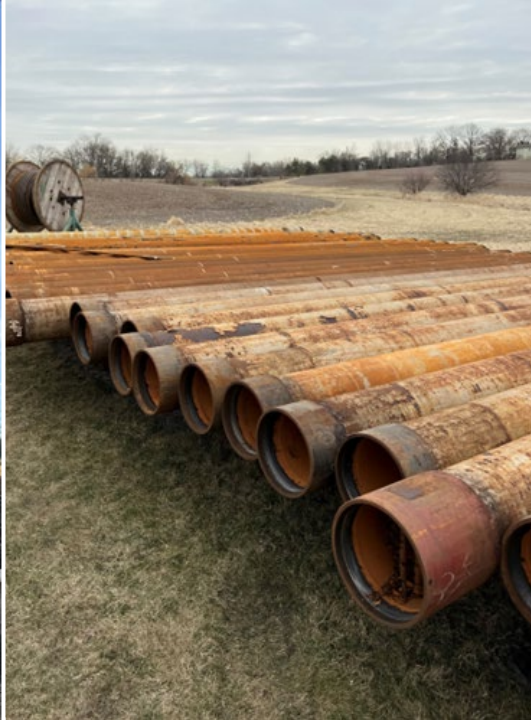
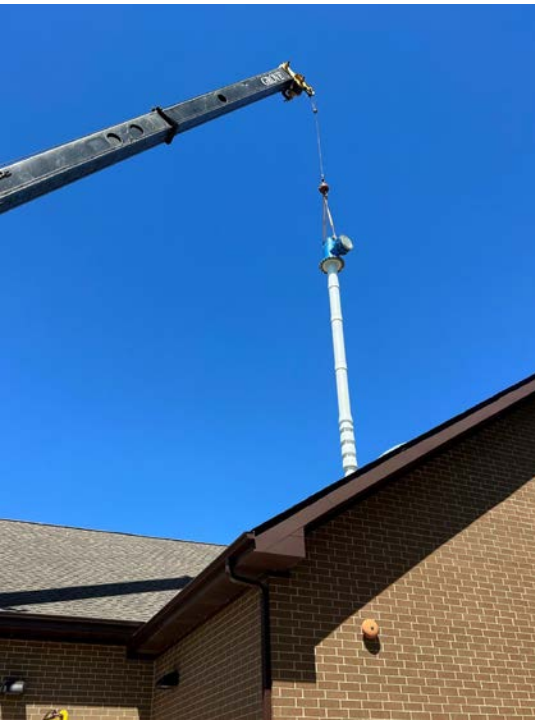
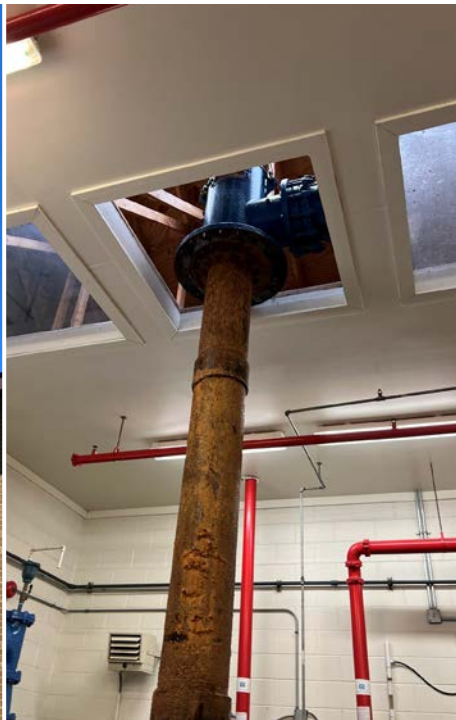
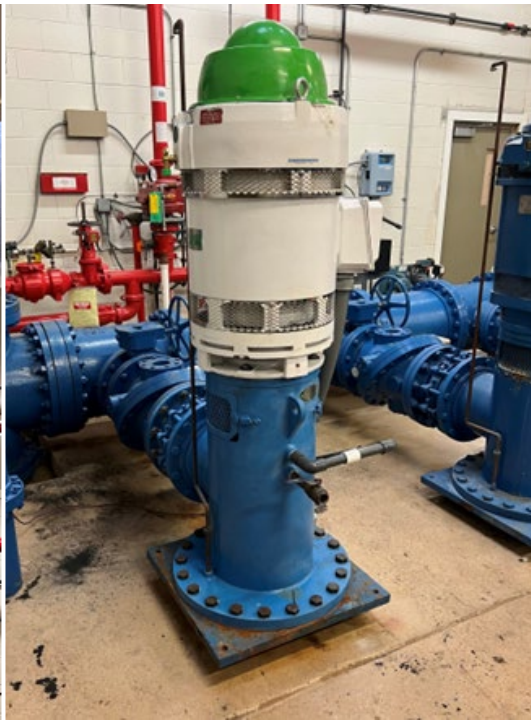
# DEEP WELL AND HIGH SERVICE PUMP REHAB

- All equipment pulled and inspected
- All work phased to minimize disruption to operations
- Wells' motors reused and pumps replaced
- New level transducers for Wells
- Planned HSP motors' replacements

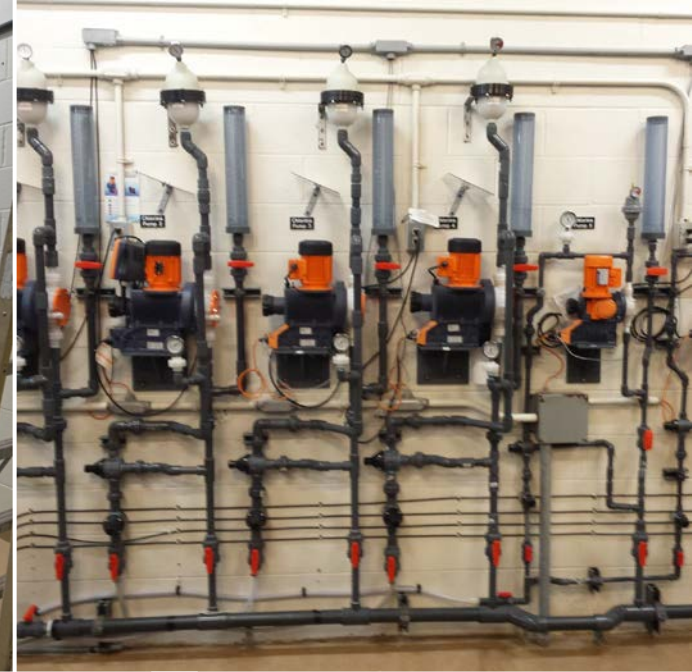
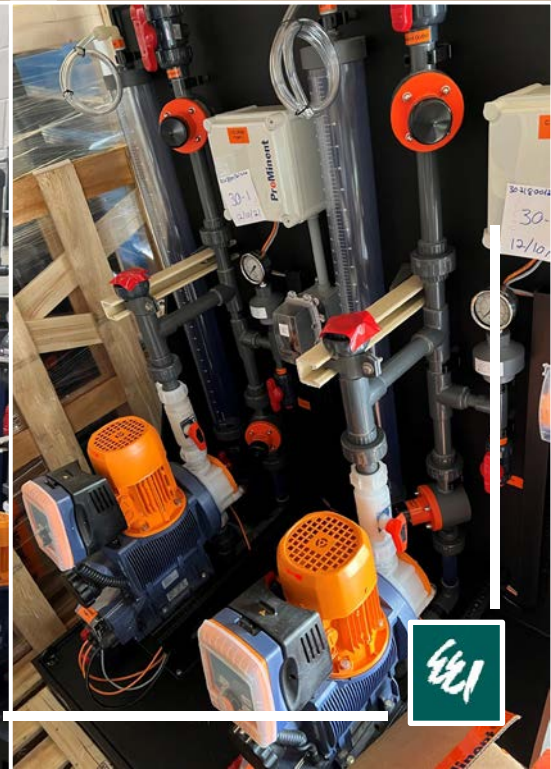
# SODIUM HYPOCHLORITE PUMPS

- New pump skids installed in old brine area
- Replaced existing wall mounted pumps
- New skids provide better reliability and functionality

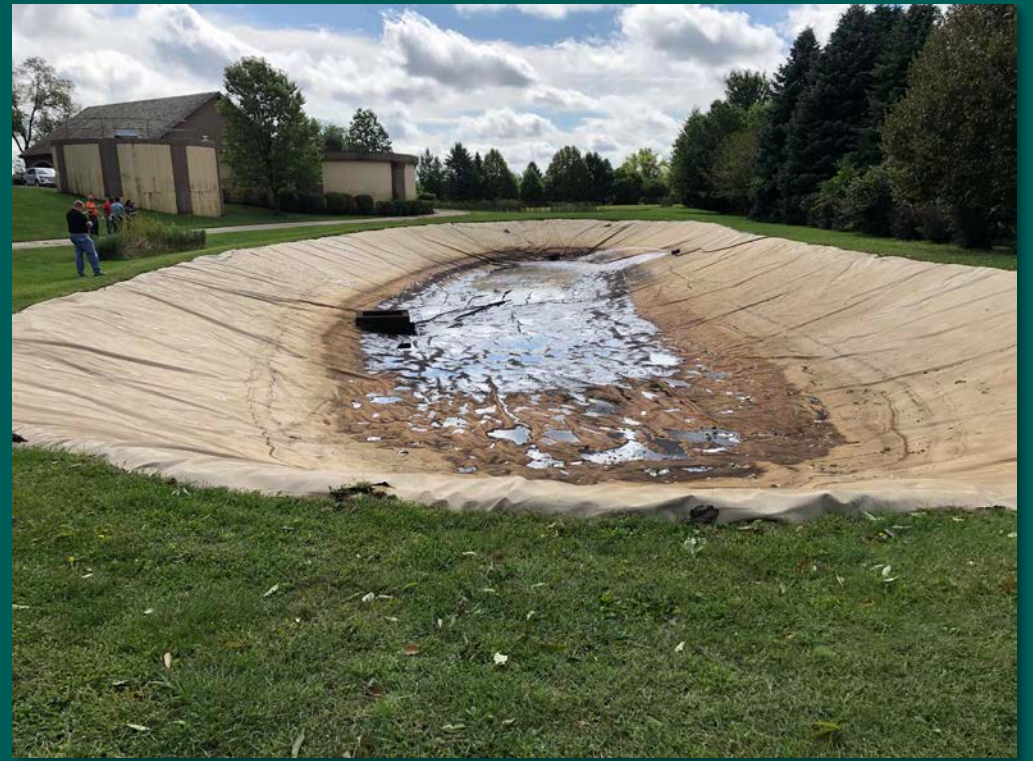
# EXISTING BACKWASH LAGOON

- Radium-laden solid accumulation requiring periodic disposal as special waste
- Frequent high-volume washdowns of lagoon (average 1,300,000 gallons/year)
- Open to environment
- Safety concerns

- Prevent solid accumulation
- Improve operational efficiency
- Improve safety

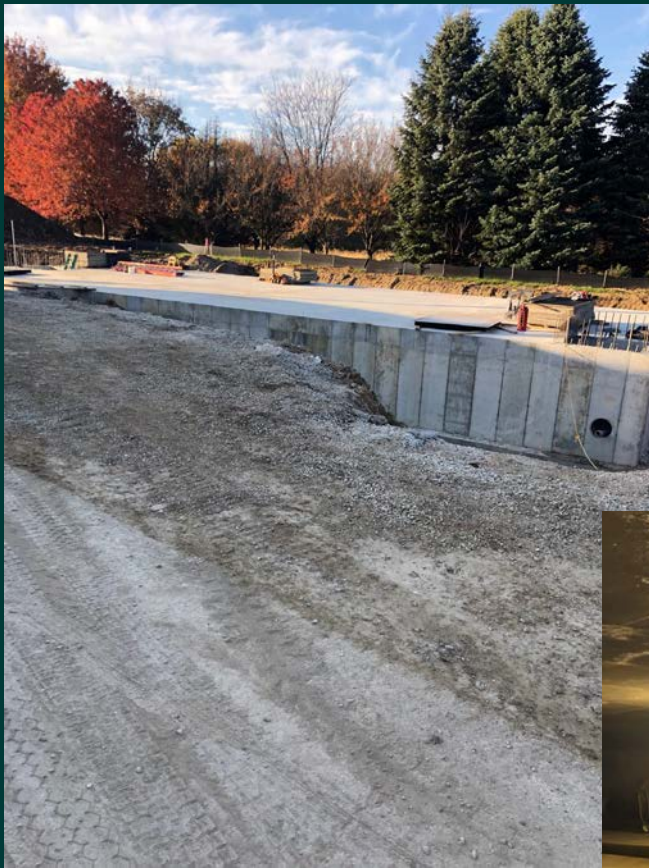
Underground backwash storage tank during construction

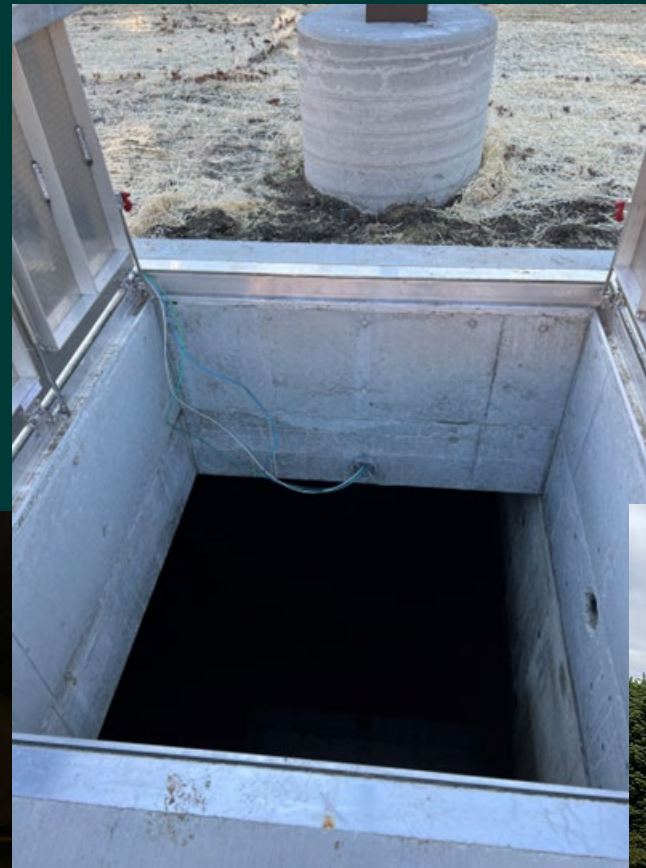
New access hatch to access underground backwash tank

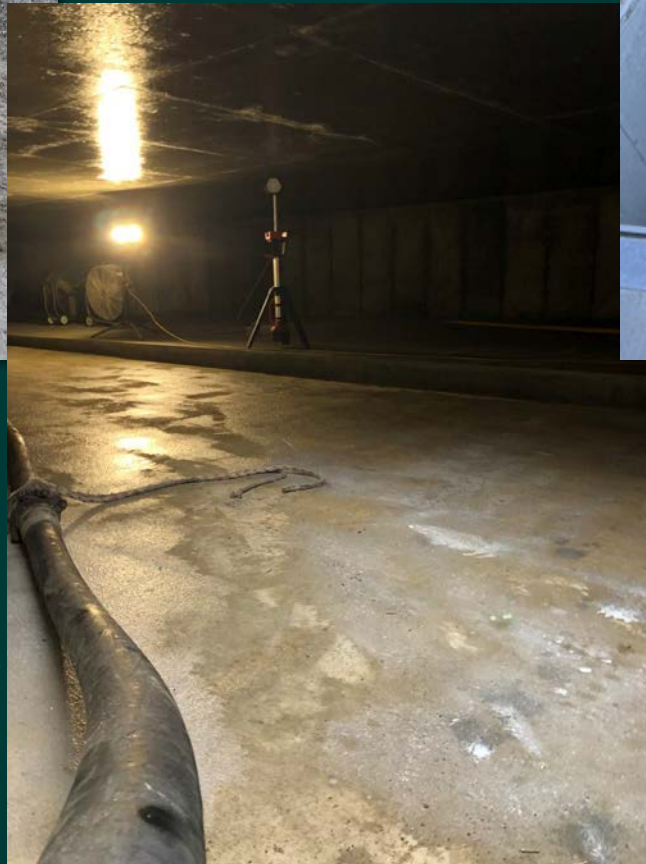
Sloped tank floor to prevent solids accumulation and to direct flow to effluent

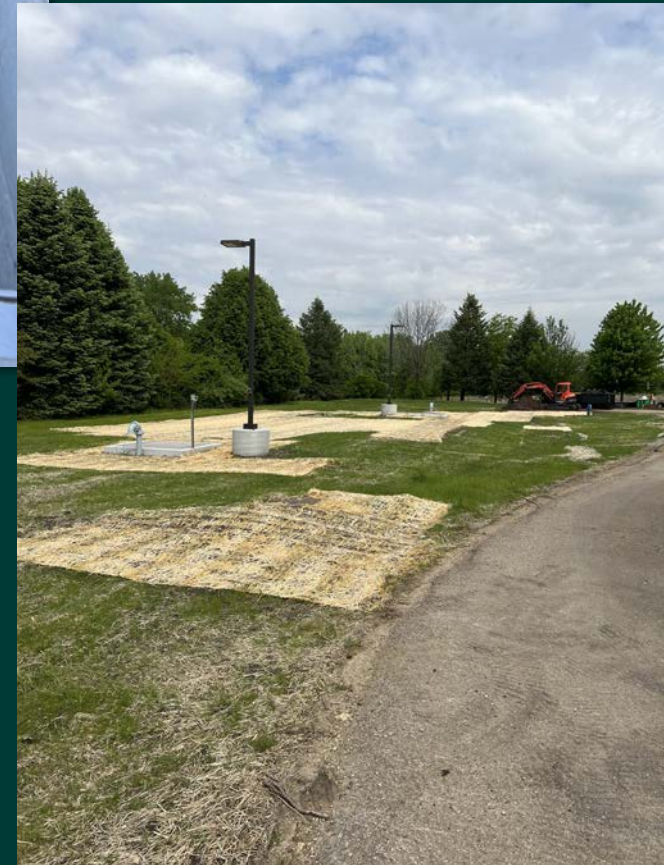
Old lagoon filled in and site regraded and seeded over backwash tank

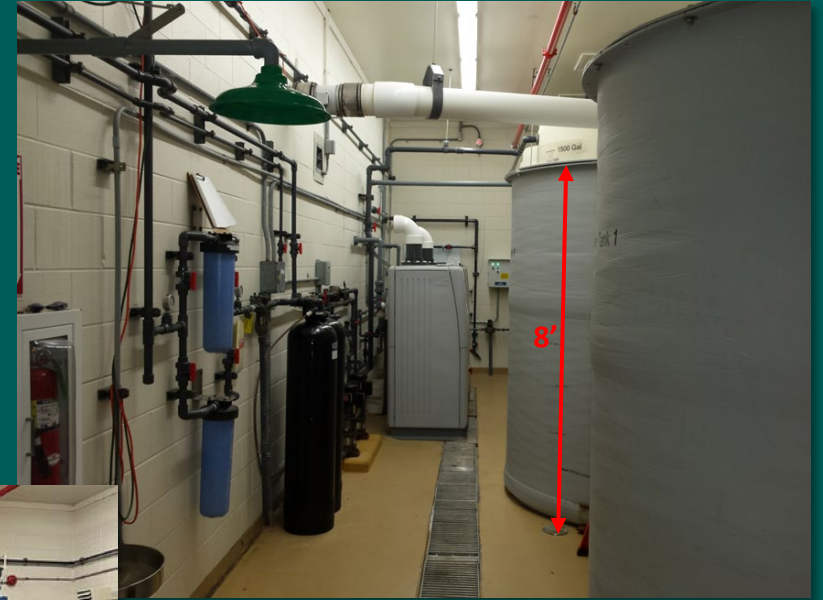
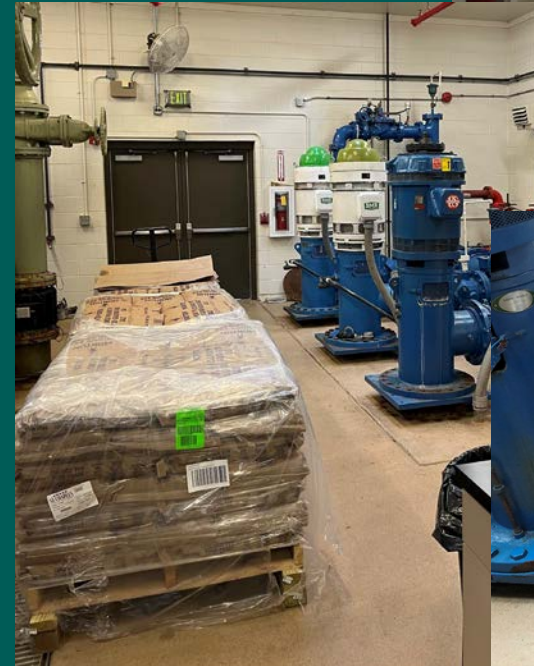
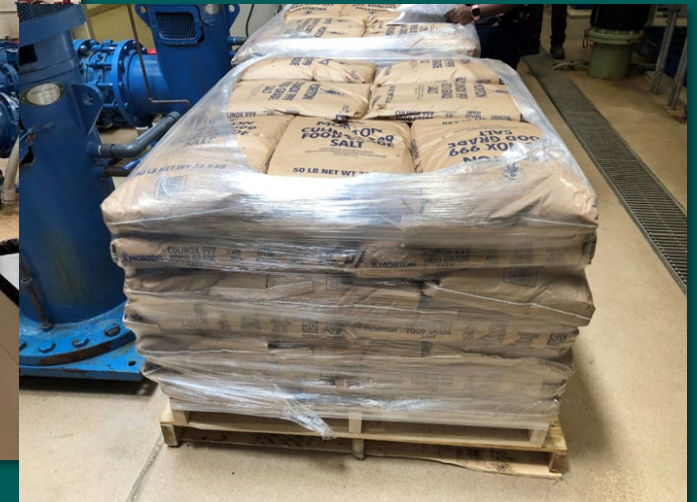
# EXISTING BRINE AREA

- Brine tanks located in cramped room along with chlorine generators, sodium hypochlorite tanks, and misc. piping
- Very difficult for operators to load salt into brine tanks (safety concerns)
  - 8 pallets of salt, 49 bags per pallet loaded one bag at a time up a ladder into tanks
- No dedicated salt storage location

- New brine tanks in recessed area
- Added salt storage space

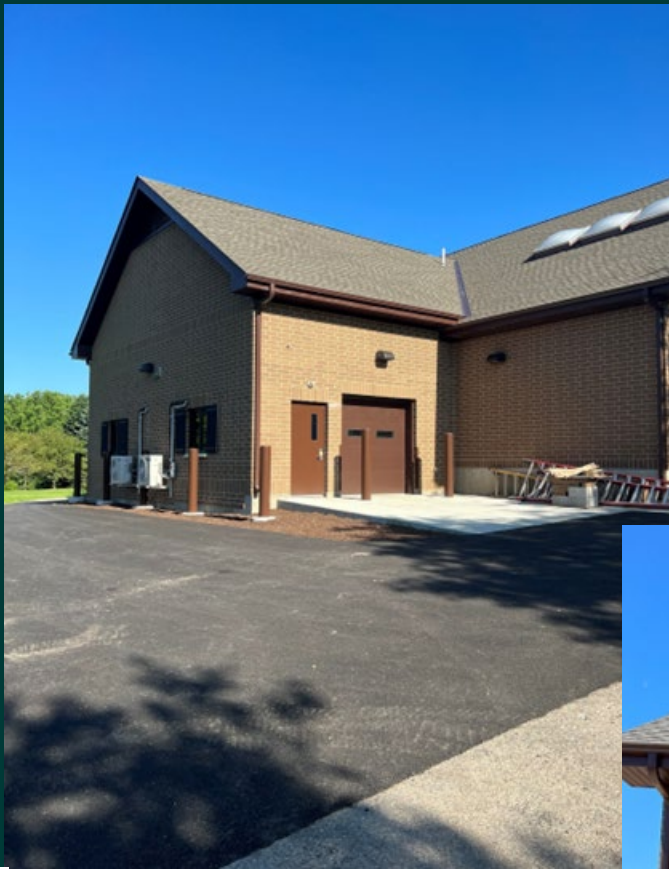
Completed Brine addition with relocated access road

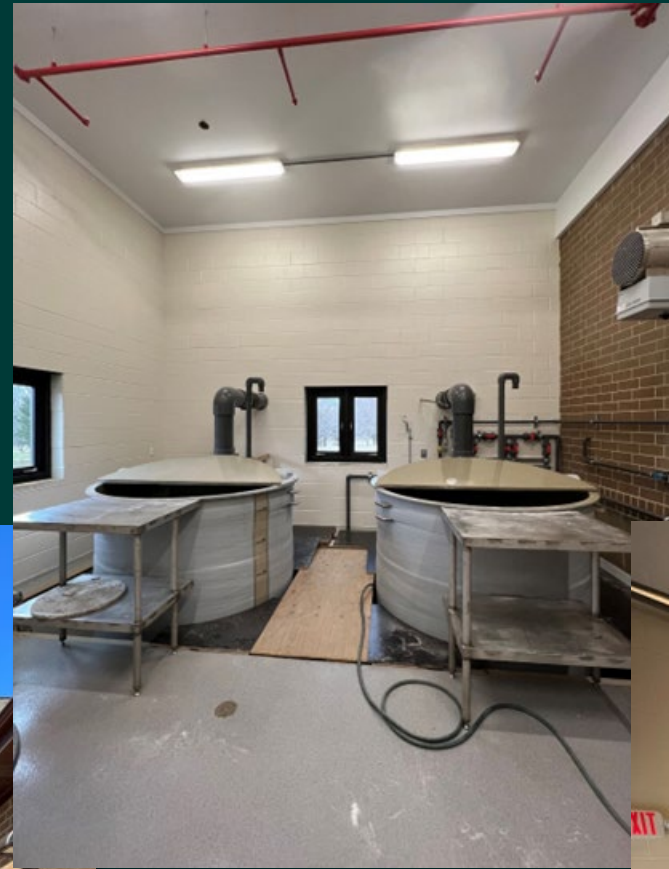
Recessed brine tanks and brine piping, new tables for easy salt loading

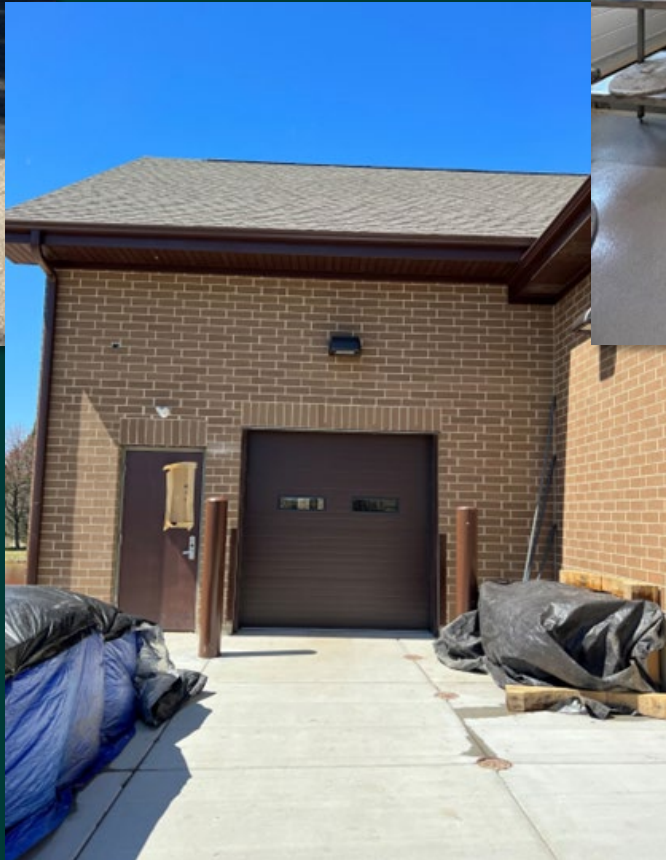
New concrete loading dock and overhead access door

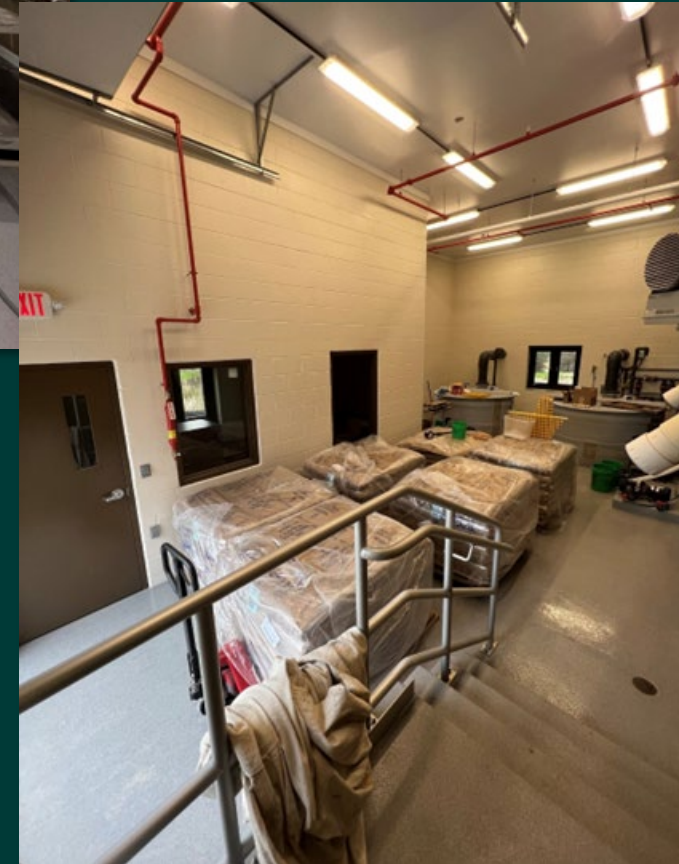
Interior salt storage space, new office, and new bathroom

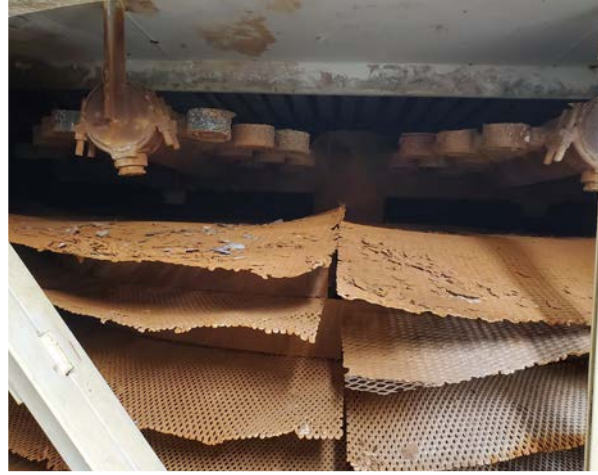
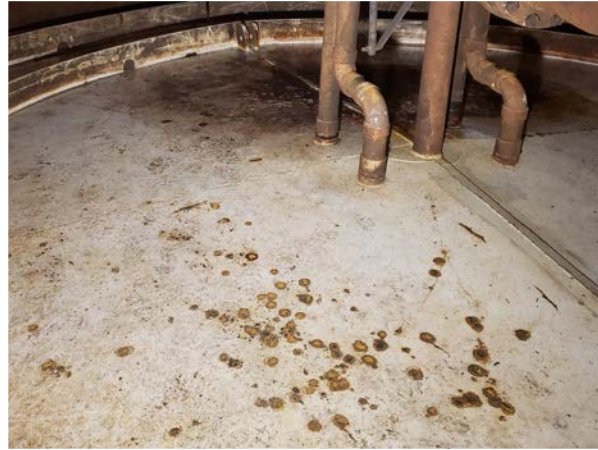
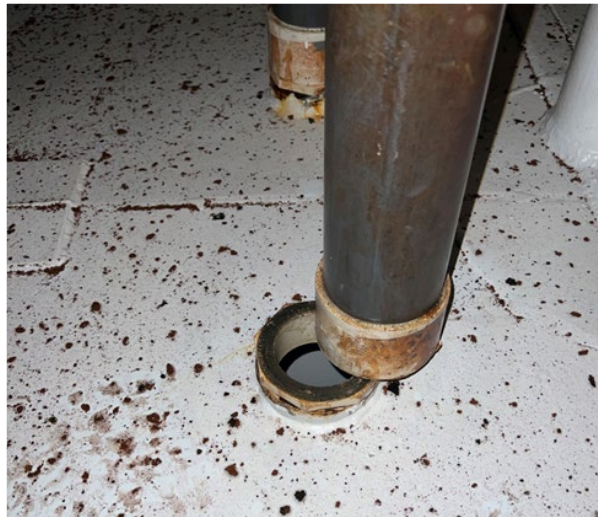
# DUALATOR 2 CONDITION

- Aerator trays in worse condition than expected and required replacement
- Aerator spray nozzles required replacement

- Detention tank floor had severe pitting

- PVC vent lines damaged
- HMO feed piping and Detention Tank drain line to be replaced

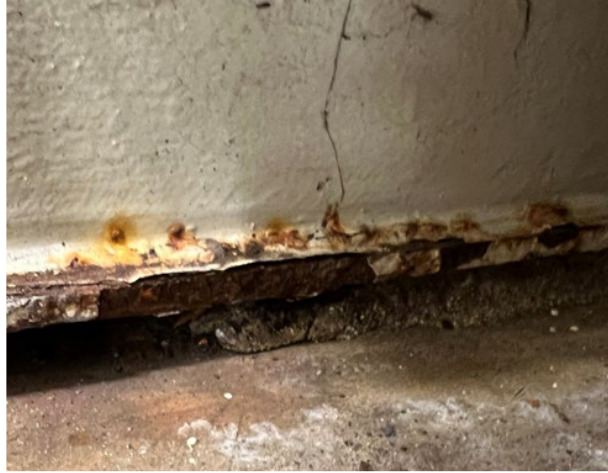
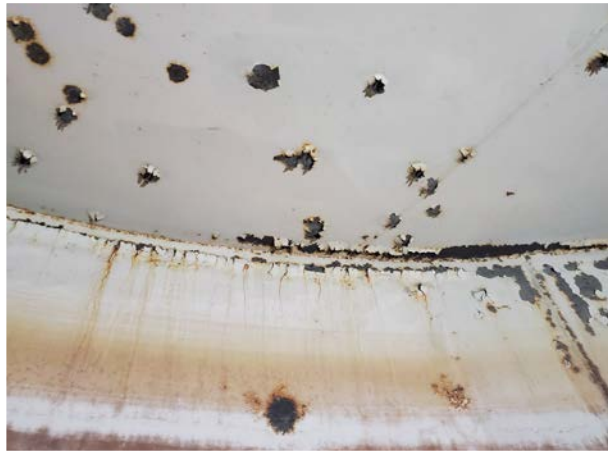
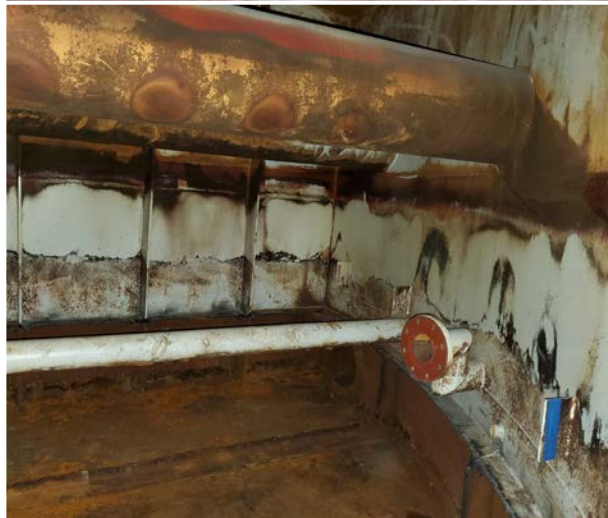
# DUALATOR 2 CONDITION

- Concrete pad required minor repairs and sealing

- Interior required full sandblasting and recoating
- Exterior required cleaning and topcoat

- Underdrain required replacement and concrete fill (planned)

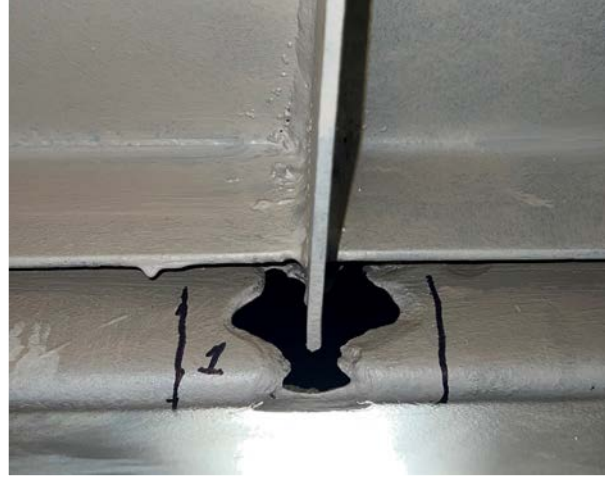
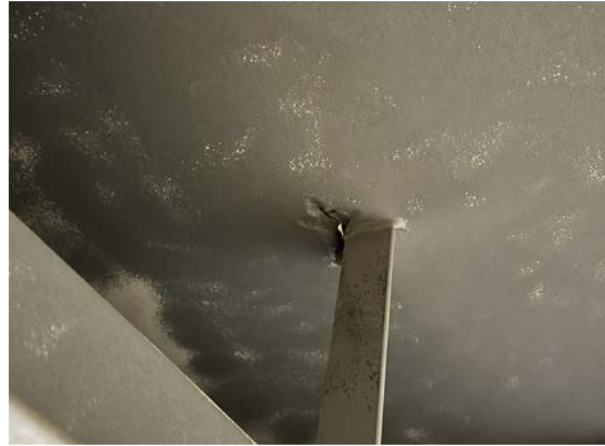
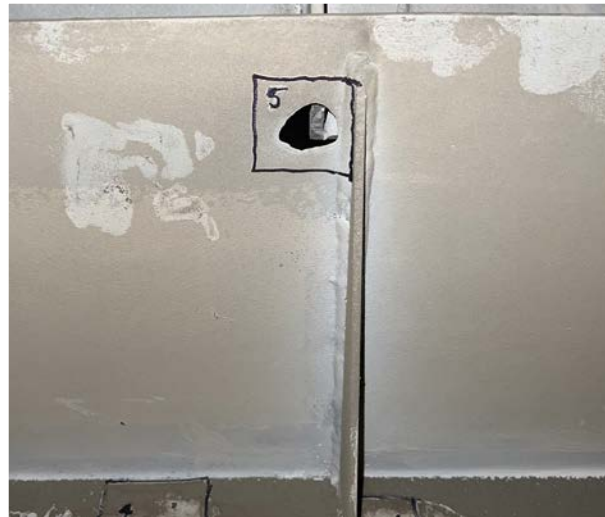
# DUALATOR 2 CONDITION

- Welds failed on structural supports
- Welds failed on trough support components
- Pitting in trough steel
- New structural supports required for all troughs
  - Solution identified that did not require full trough replacements (cost savings)

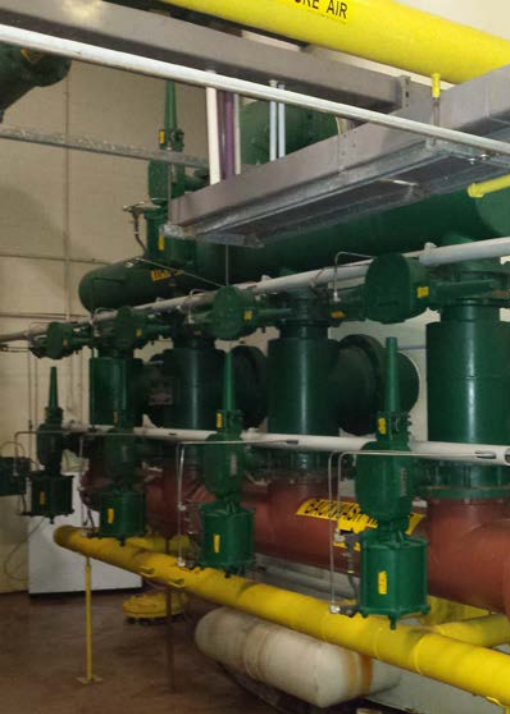
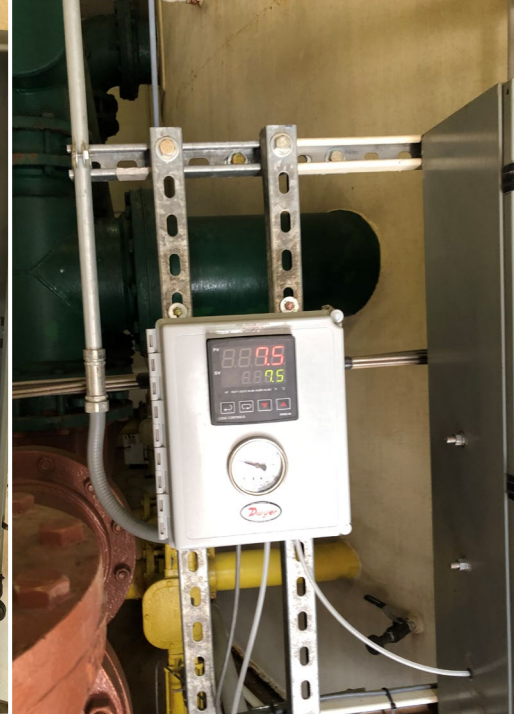
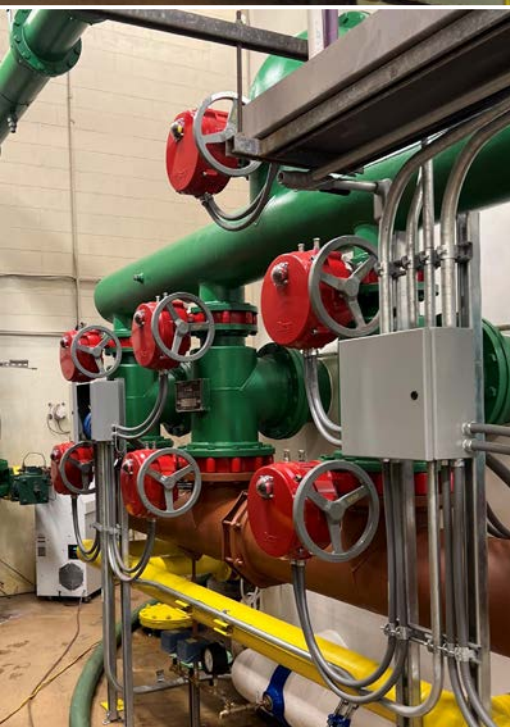
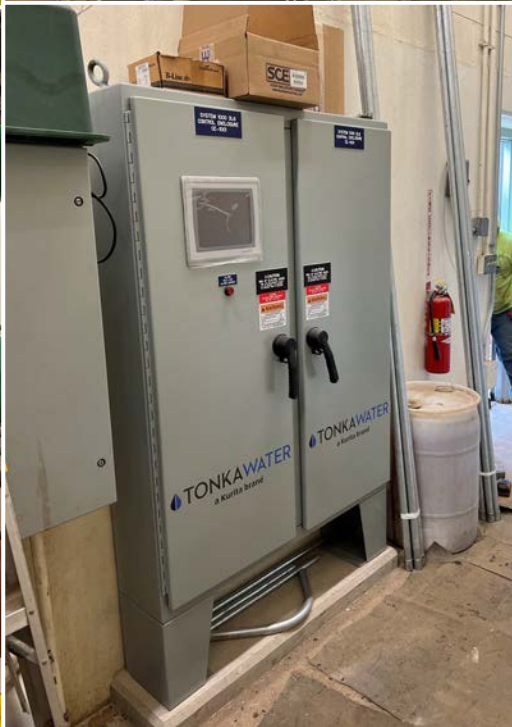
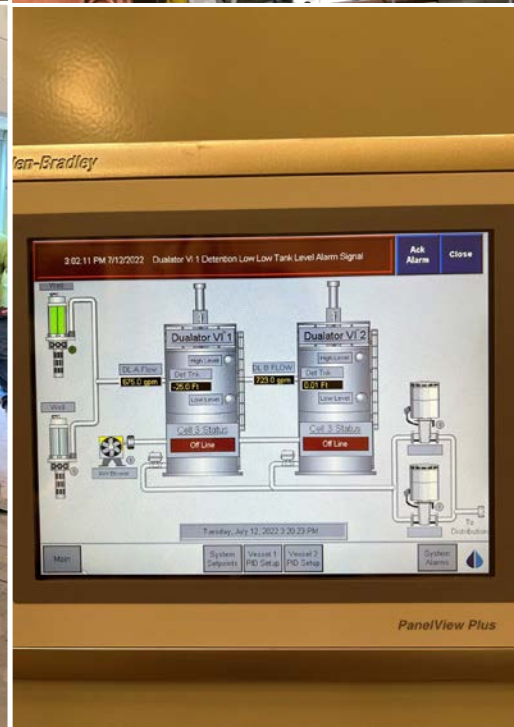
# DUALATOR VALVES

- Original System:
  - Pneumatic Valves
    - No Manual Operation Mode
  - Airlines Tied in Control Cabinet
  - Limited SCADA Capabilities
- New System:
  - Electric Actuated Valves
    - Manual Handwheel
  - Automated Display Cabinet
  - Added SCADA Capabilities

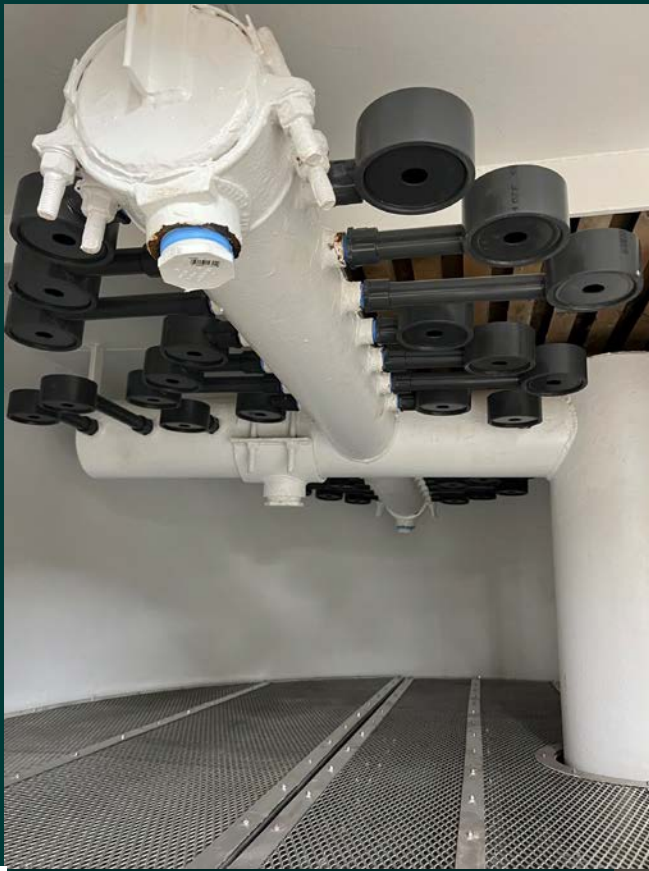
Fully recoated  
aerator with new  
nozzles and spray  
trays

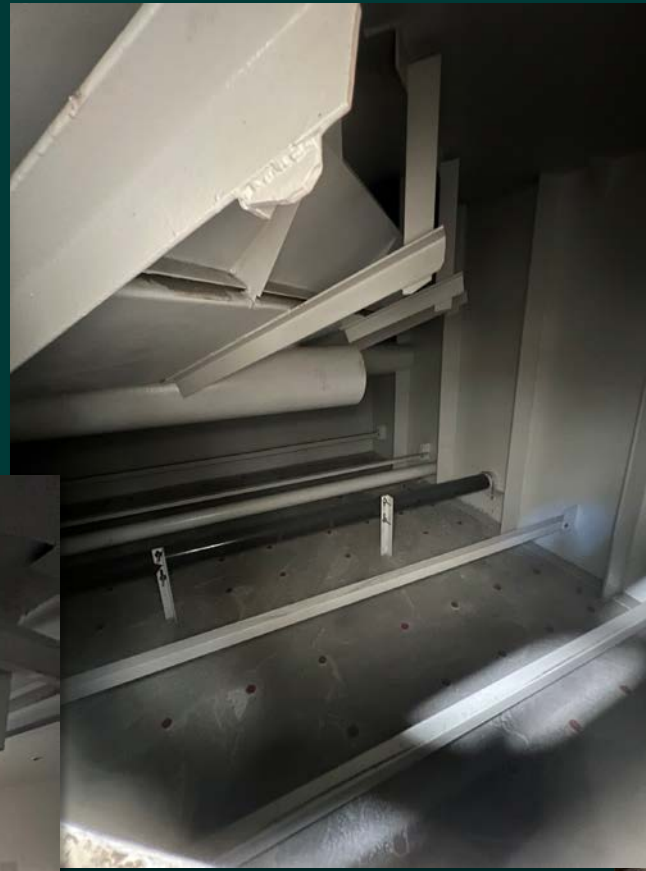
Fully recoated filter  
cells with new trough  
supports and  
concrete underdrain  
system

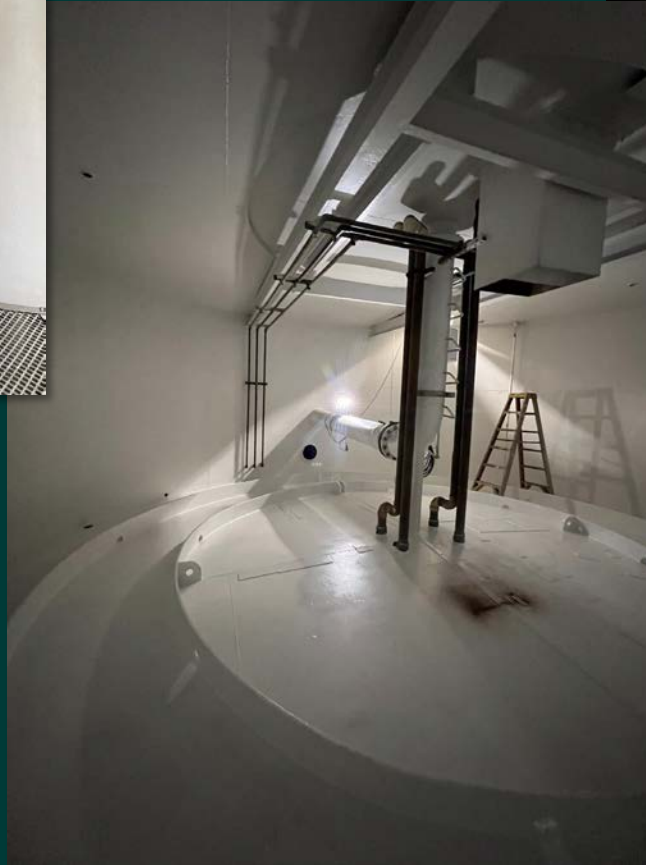
Fully recoated  
detention tank with  
new HMO piping,  
drain valve, and  
PVC vents

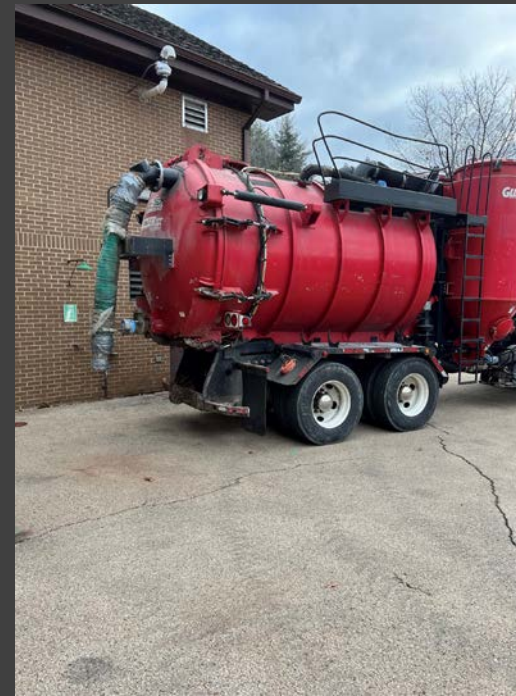
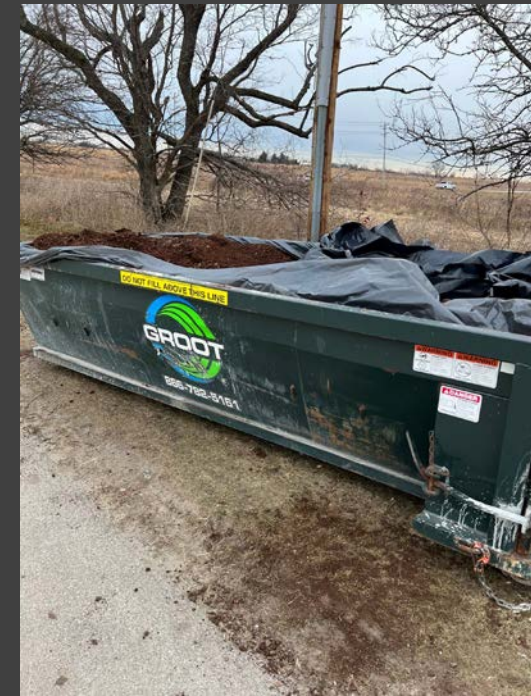
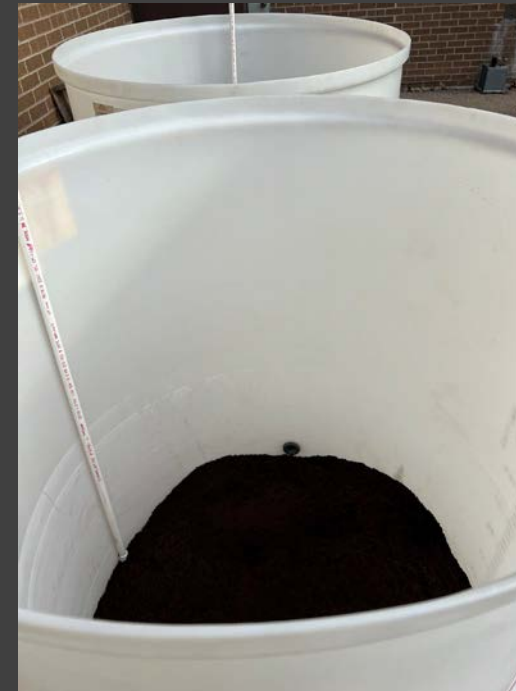
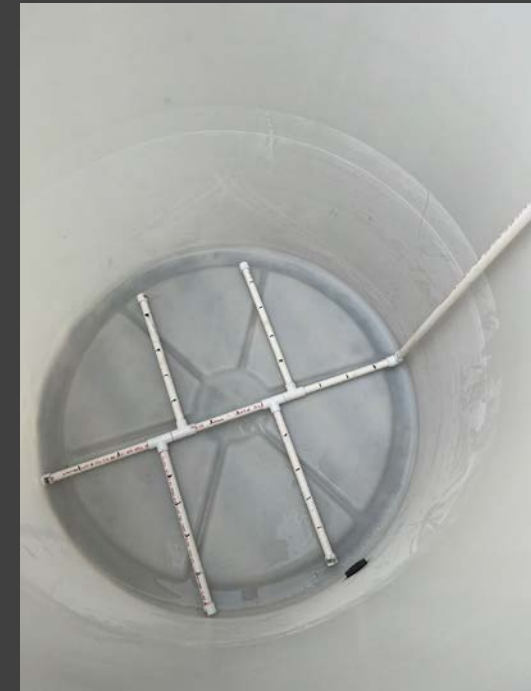
# STRATEGY TO MAINTAIN BIOLOGY

- ~165 gallons of media pulled from each filter cell of each Dualator and stored in small tanks as seed media
  - Approx. 1/12 of total media
  - Total remaining media removed and disposed = 7,280 gallons
- Raw water pumped through storage tanks to keep media biologically active
- Existing media was used to re-seed new media with nitrifiers when installation occurred
